Proxer12 firmware update

We are done with the updated software, which fixes the reading error of TIRIS cards. To do this, please update the software on the devices. The process is:

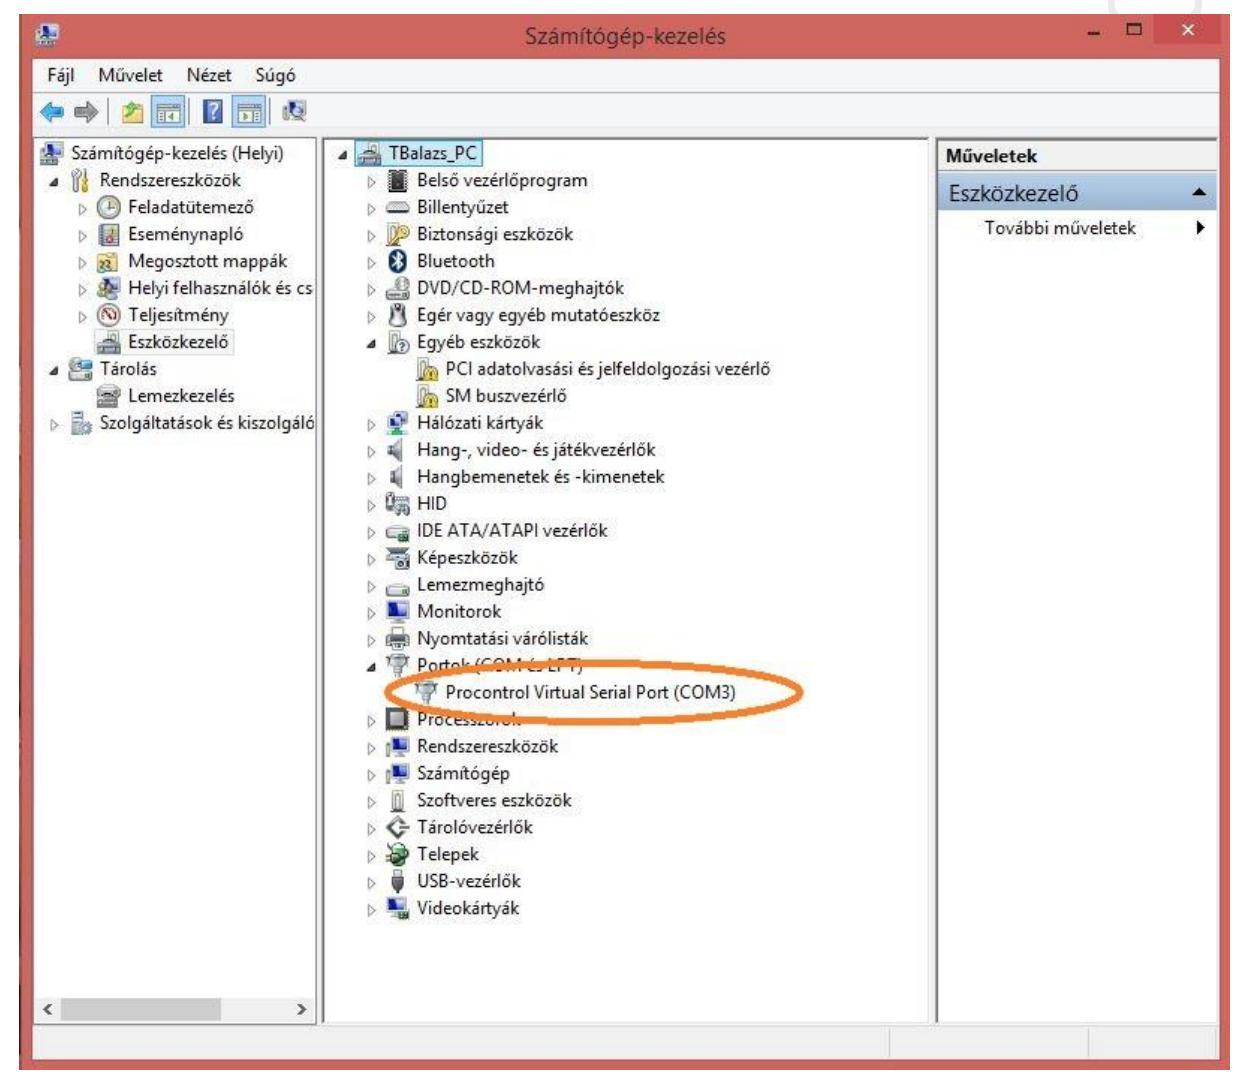
To which computer the device is connected, check in the 'Device manager' what serial port (COM port) the device has been given. This port must be specified later in the utility program.
